Rimkus Consulting Group, Inc.
Eight Greenway Plaza, Suite 500
Houston, TX 77046
(800) 580-3228 Telephone
(713) 623-4357 Facsimile

Re: RCG File No: 11009971
LLV Number: 0209452
VMF Location: 1530 Greensmark Drive in Houston, Texas
Subject: Final Report

Rimkus Consulting Group, Inc. was retained to examine LLV 0209452, VIN 1GBCS10E4M2908832. The fire occurred on June 13, 2016 at around 12:30 P.M. the operator of the vehicle at the time of the fire, was unavailable for interview but reportedly stated the vehicle's engine died while delivering mail on his route and backfired during subsequent attempts to restart it. Soon thereafter, smoke was observed from beneath the hood as well as flames.

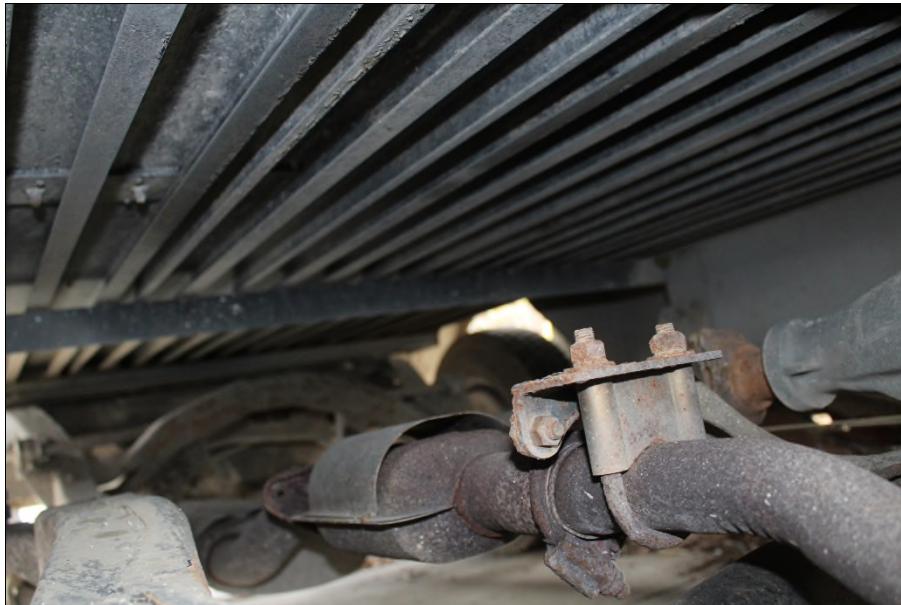
Photograph 6

We did not observe any direct fire damage to the portion of undercarriage for the cargo compartment and driver compartment. We observed heat and direct fire damage to the portion of undercarriage for the engine compartment. All patterns indicated the fire travel was from the engine compartment to the undercarriage.

Undercarriage under cargo area and driver's compartment with no direct fire damage.

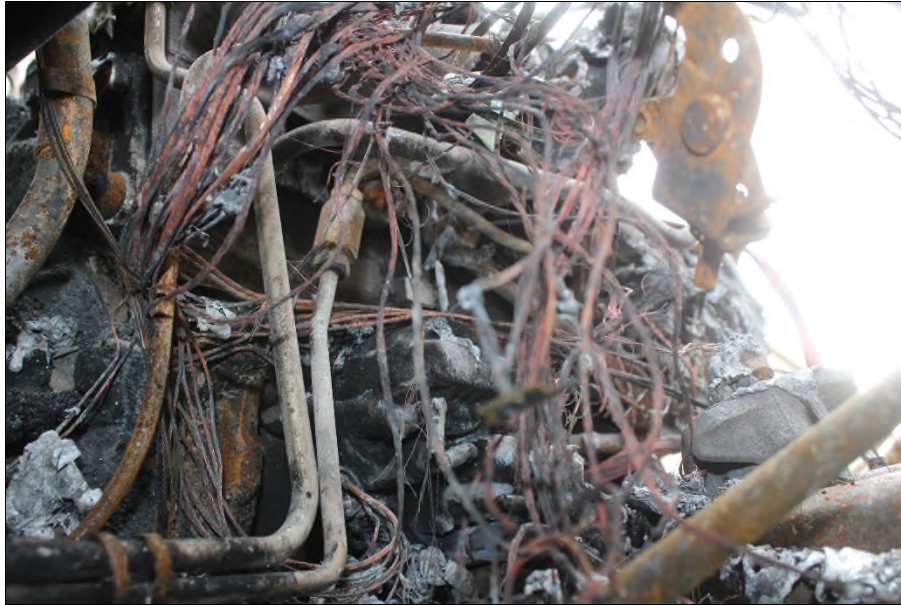
Photograph 7

Undercarriage under the engine compartment with direct fire damage. All patterns indicated the fire originated in the engine compartment.

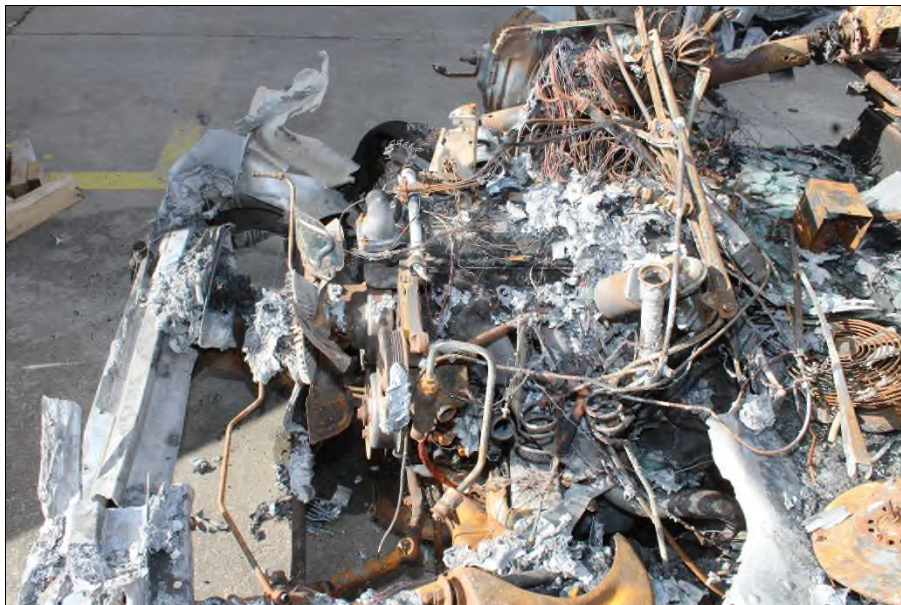
Photograph 8

Mail side of the engine compartment with heat and direct fire damage. All patterns indicated the fire travel was from the driver side to the mail side.

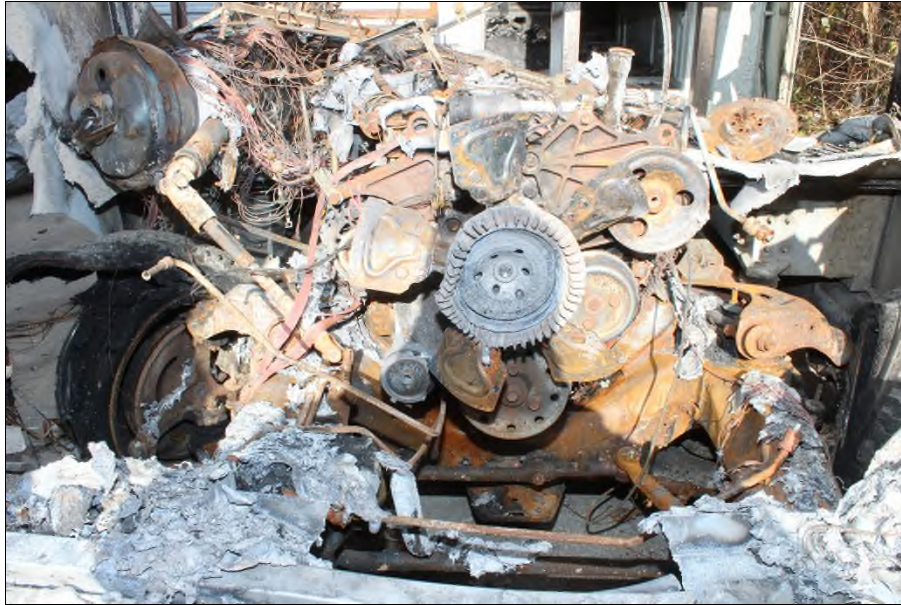
Photograph 9

Front of the engine with heat and direct fire damage. All patterns indicated the fire travel was from the driver side of the engine compartment to the front of the engine.

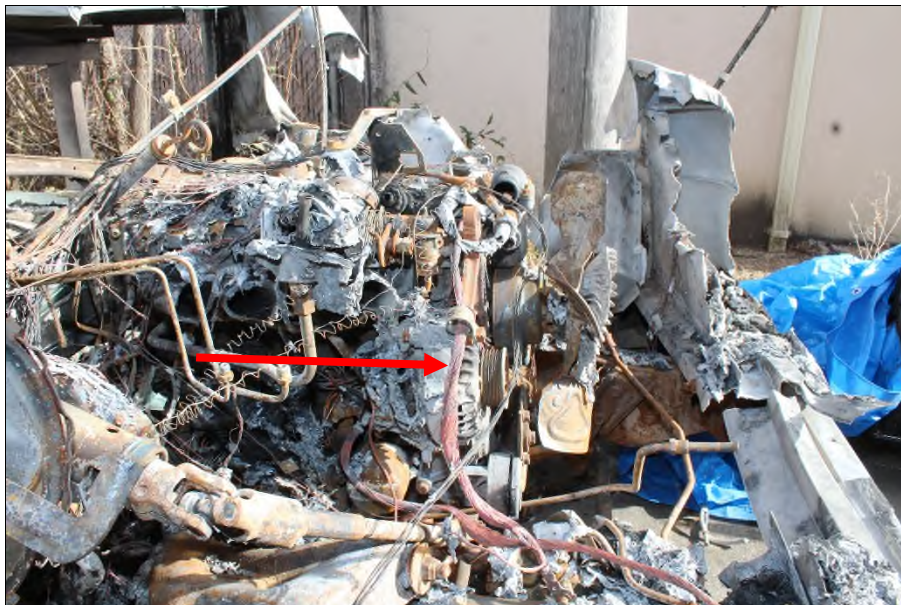
Photograph 10

Driver side of the engine compartment with heat and direct fire damage. All patterns indicated the fire travel was from the back on the engine compartment to the front.

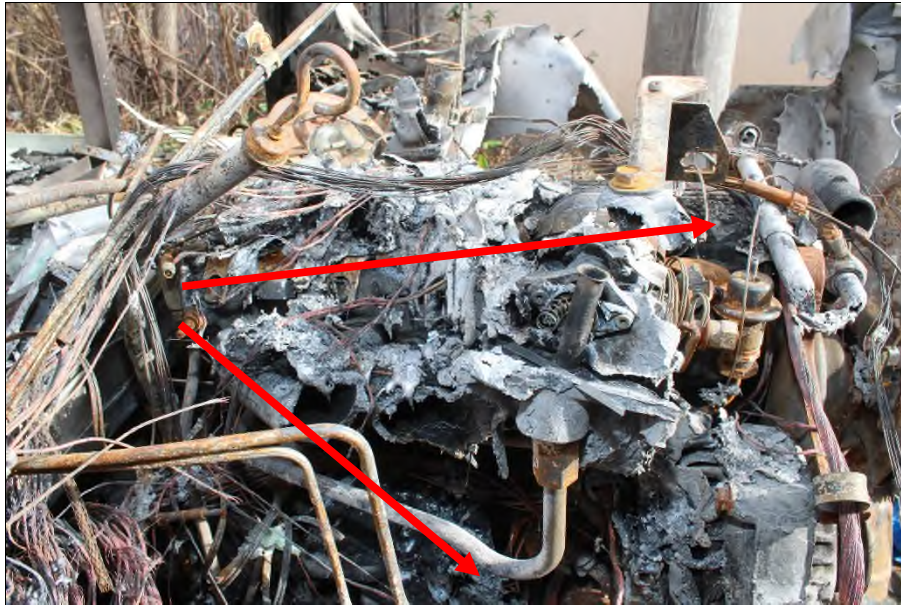
Photograph 11

Based upon the fire damage, the fire movement and intensity patterns, and a systematic evaluation of the physical evidence, we determined the fire originated in the area of the upper rear portion of the engine on the driver side. This area contained the incoming fuel line, connection, and fuel rail.

All patterns indicated the fire originated in the area of the fuel line connected and fuel rail.

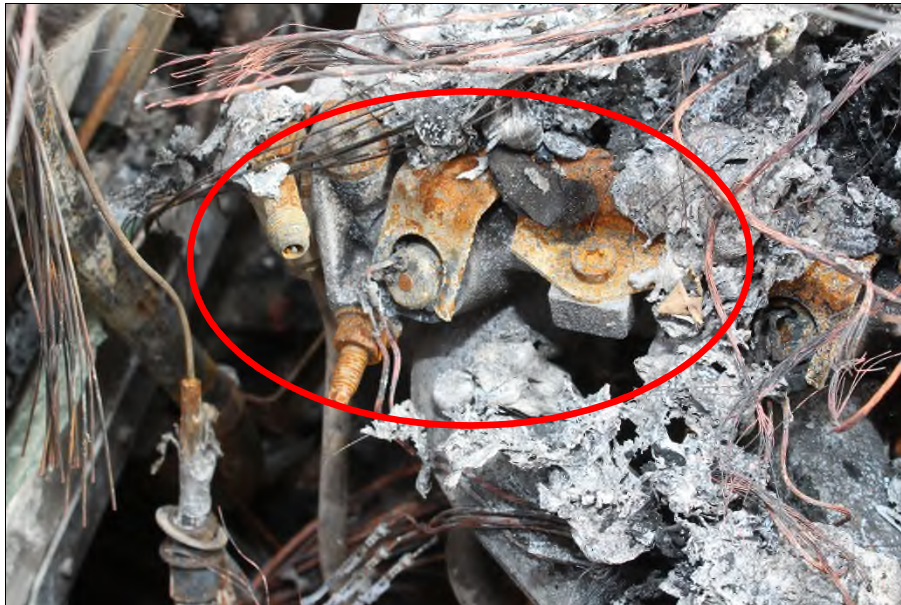
Photograph 12

fire damage with oxidation to the metal components. We observed the greatest degree of oxidation and damage was to the rear portion of the fuel rail and incoming fuel line connection. All patterns indicated this was the area of origin.

Based on the remaining physical evidence, the most probable cause of this fire was from either leaking or atomized gasoline fuel being ignited from either contact with a hot surface

Area of origin was in the area of the fuel line connection and the fuel rail.

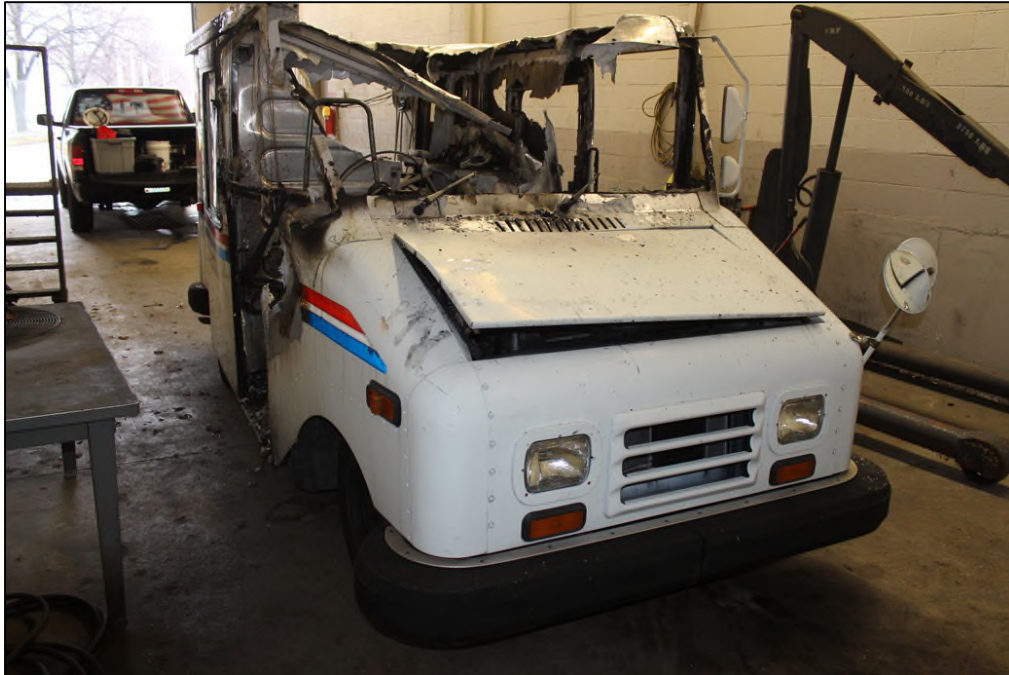
Photograph 1

Driver compartment aluminum roof, windshield and aluminum cargo roof collapsed.

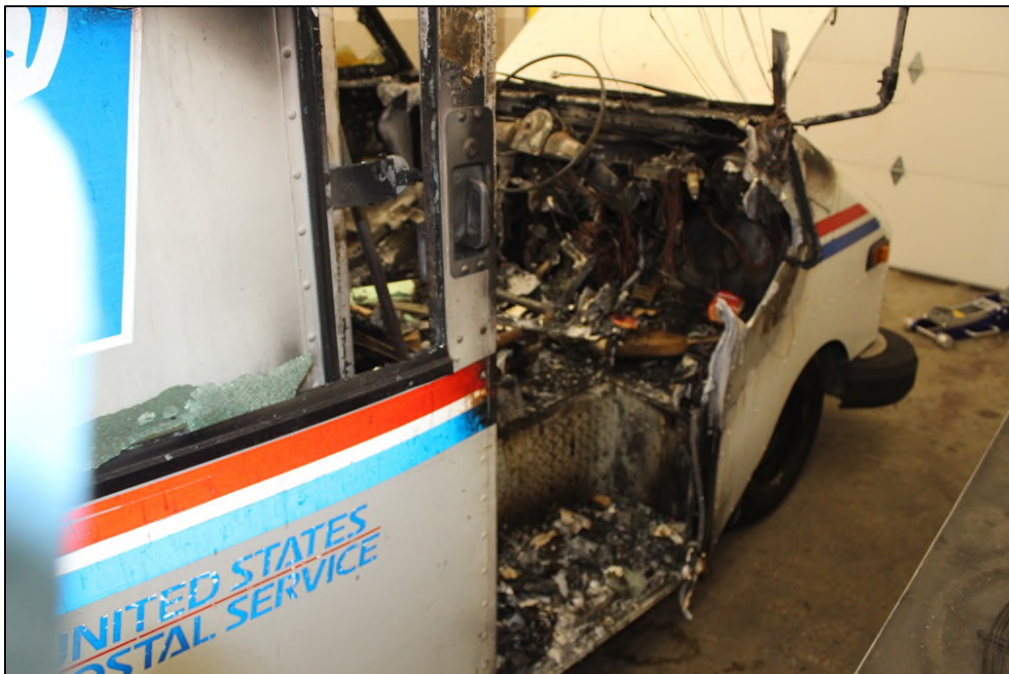
Photograph 2

Fire damage at driver compartment extending to the fender well and rear.

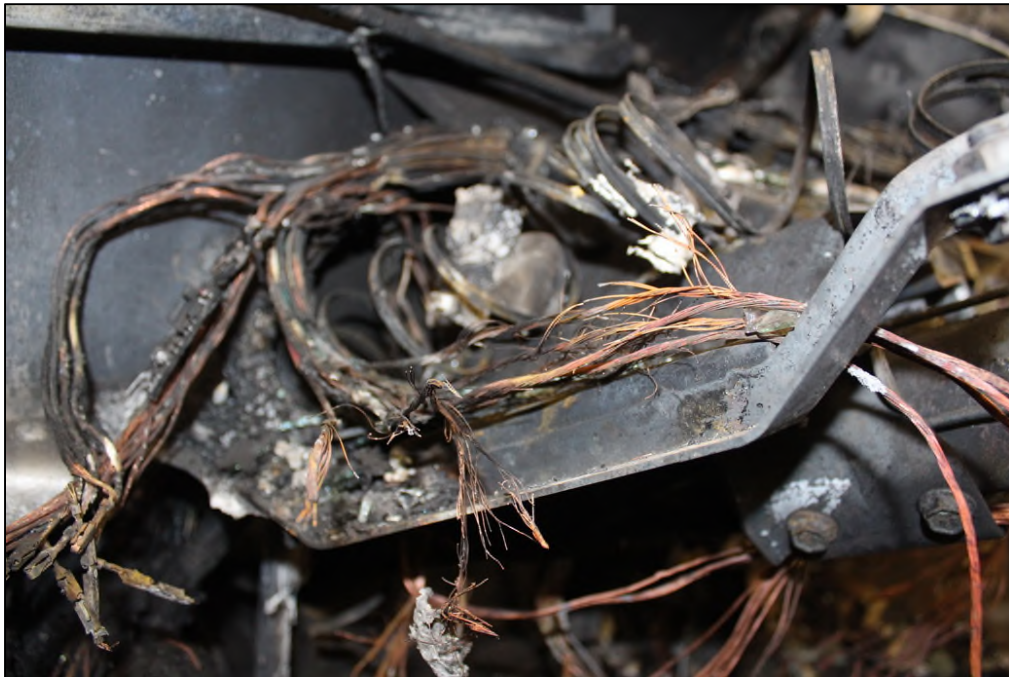
Photograph 3

Fractured electrical circuits in area of origin where the headlight switch was installed.

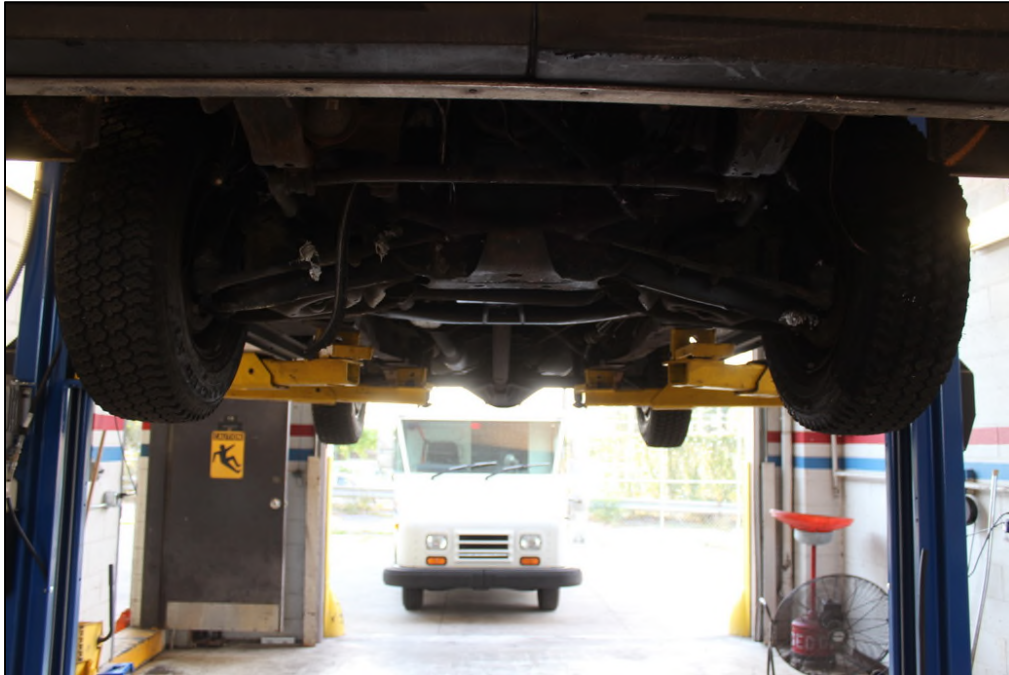
Photograph 1

Front undercarriage in good condition.

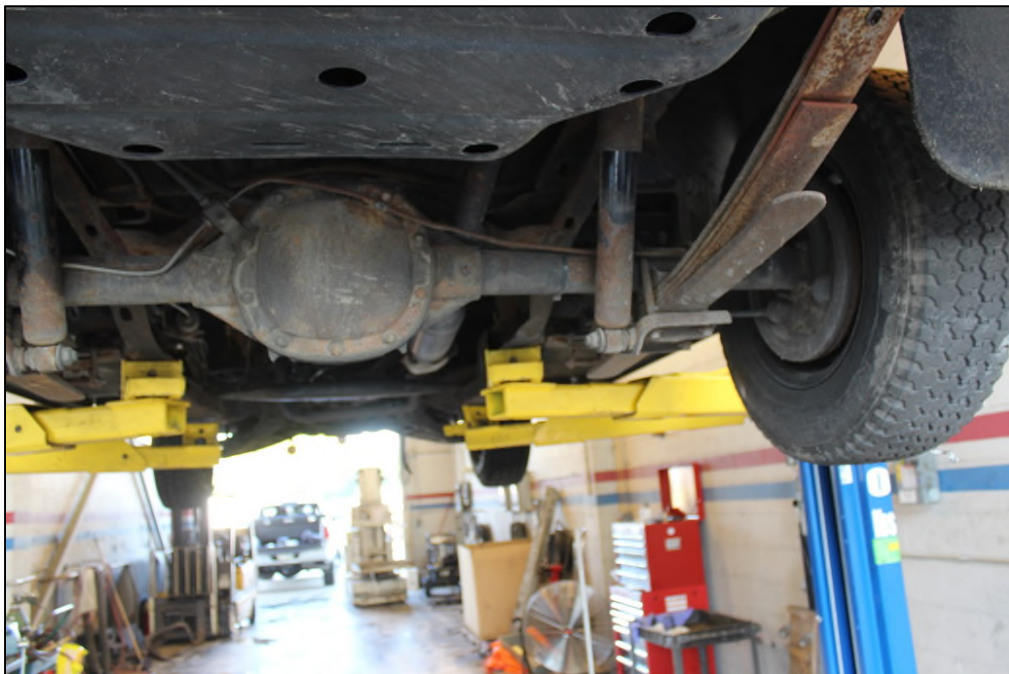
Photograph 2

Rear undercarriage in good condition.

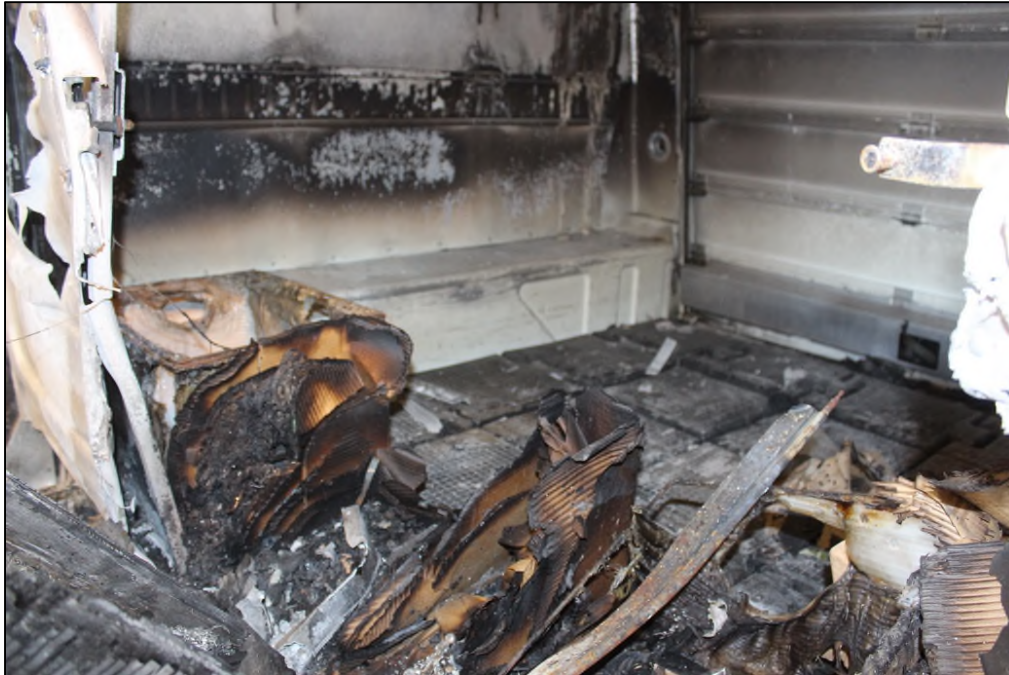
Photograph 7
Cargo compartment.

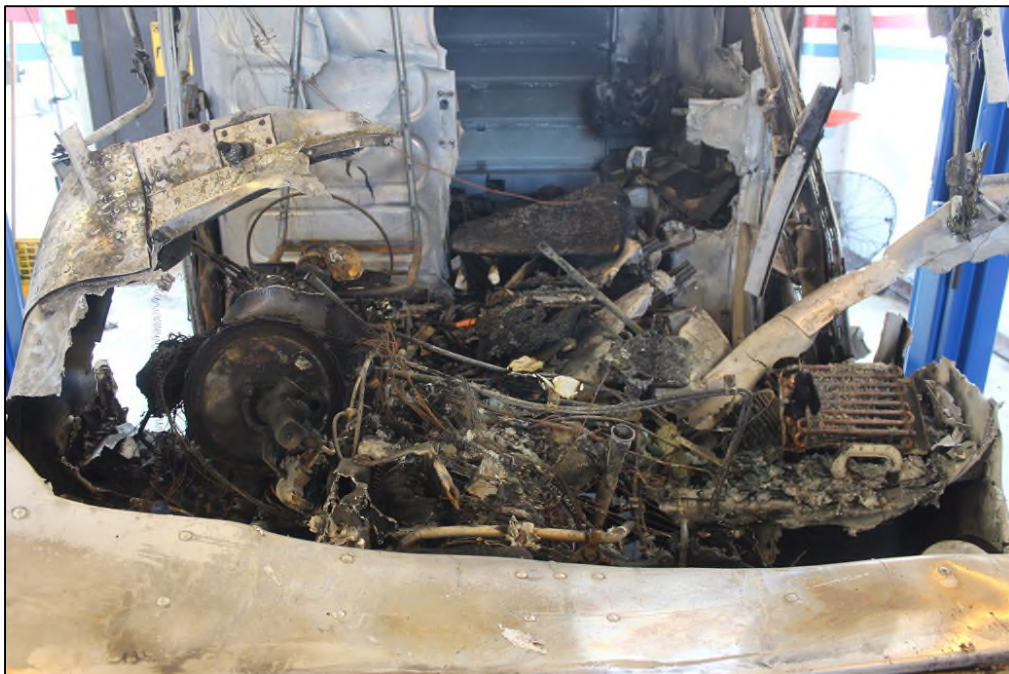
Photograph 8
Engine compartment.

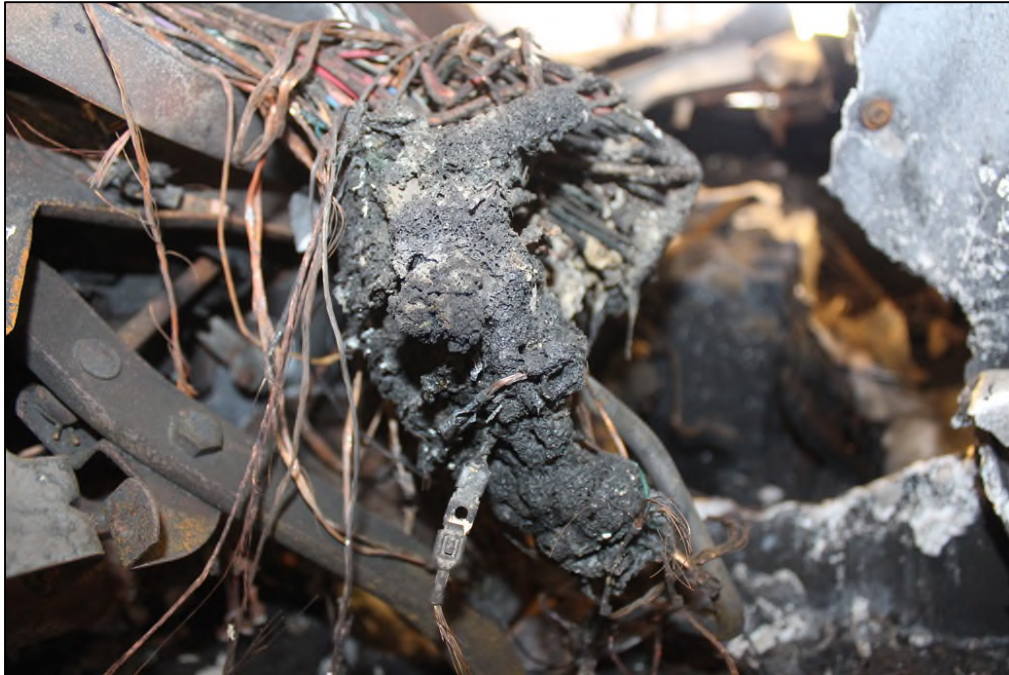
Photograph 9

Melted remains of fuse panel in driver compartment .

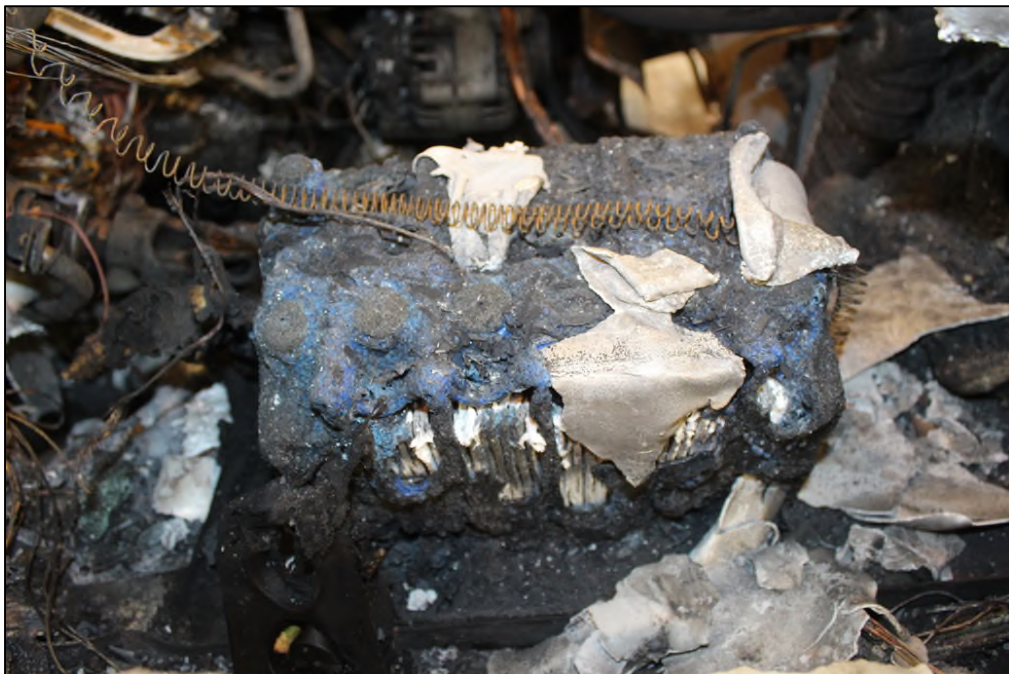
Photograph 10

Fire damaged battery.

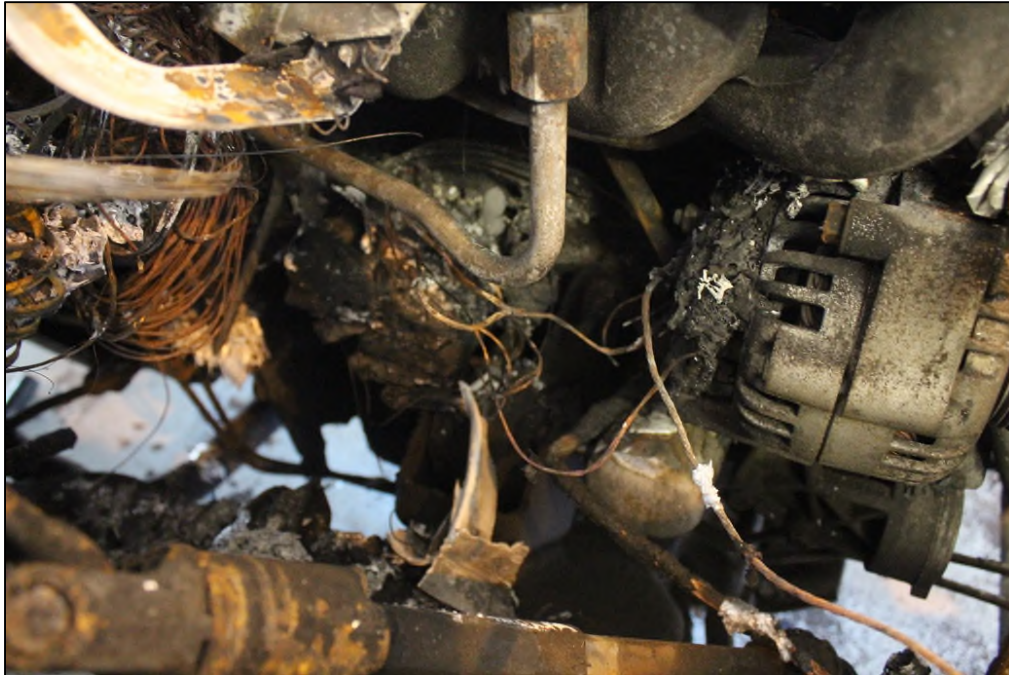
Photograph 11

Fire damaged ignition coils on driver side of engine block, area of fire origin.

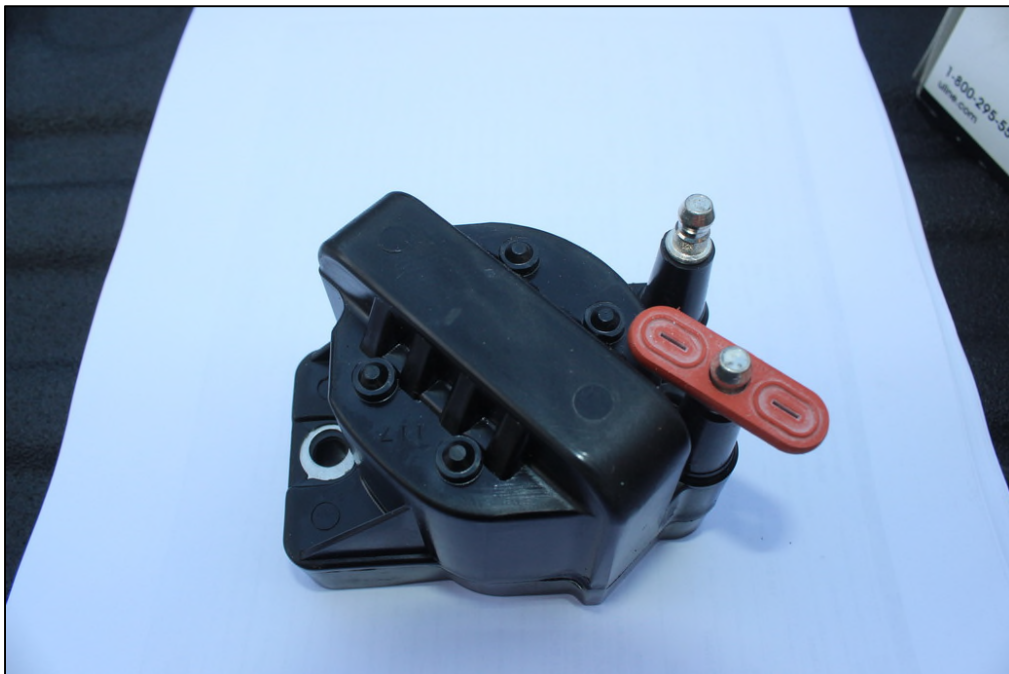
Photograph 12

Exemplar new ignition coil.

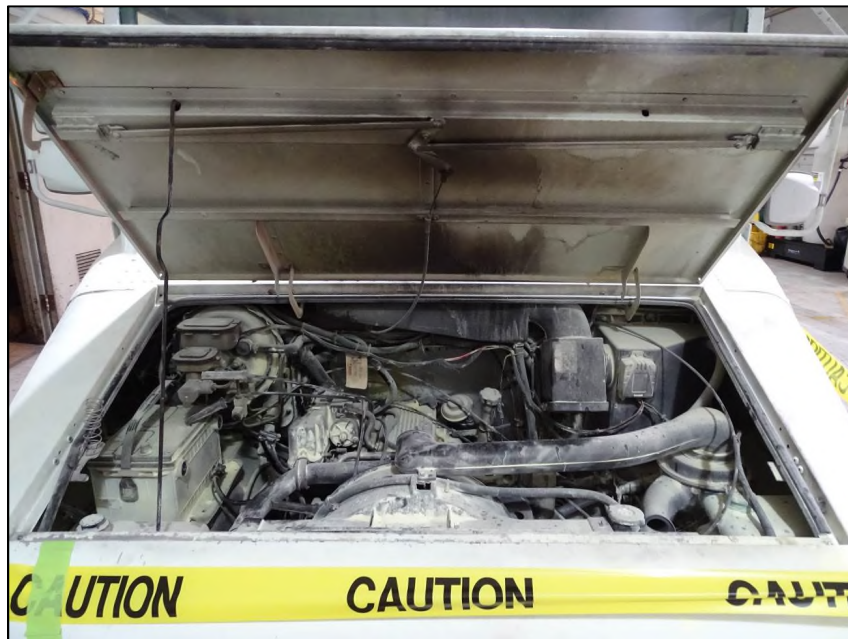
Photograph 2

The engine compartment was covered with extinguishing agent from an expelled fire extinguisher. There was fire damage to the plastic corrugated tubing protecting the electrical conductors above the back of the engine. The spark plugs had been removed

Overall view of the engine compartment.

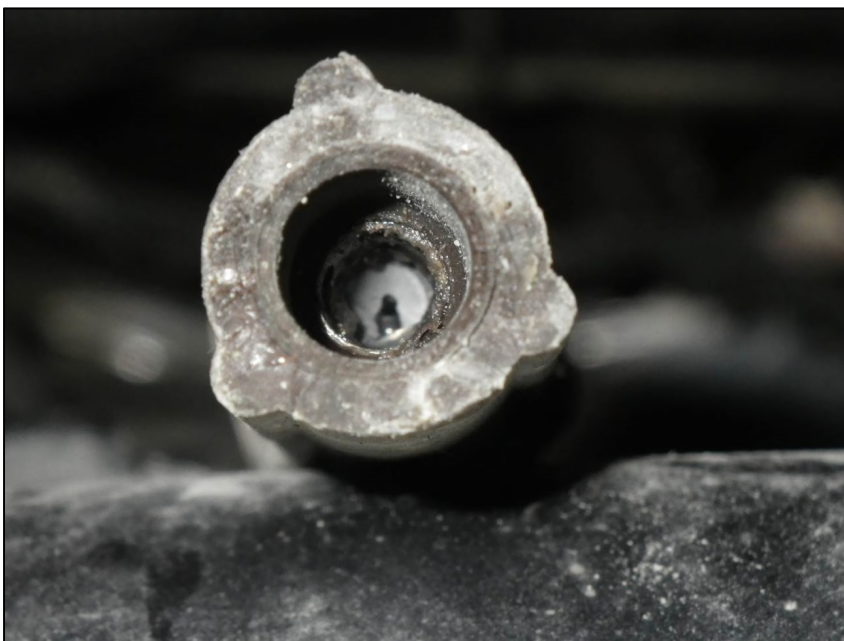
Photograph 4

The spark plug wires were lying loose in the engine compartment and were connected to the ignition. We examined the connections and identified fire damage inside the number two cylinder spark plug boot.

Number 2 spark plug wire.

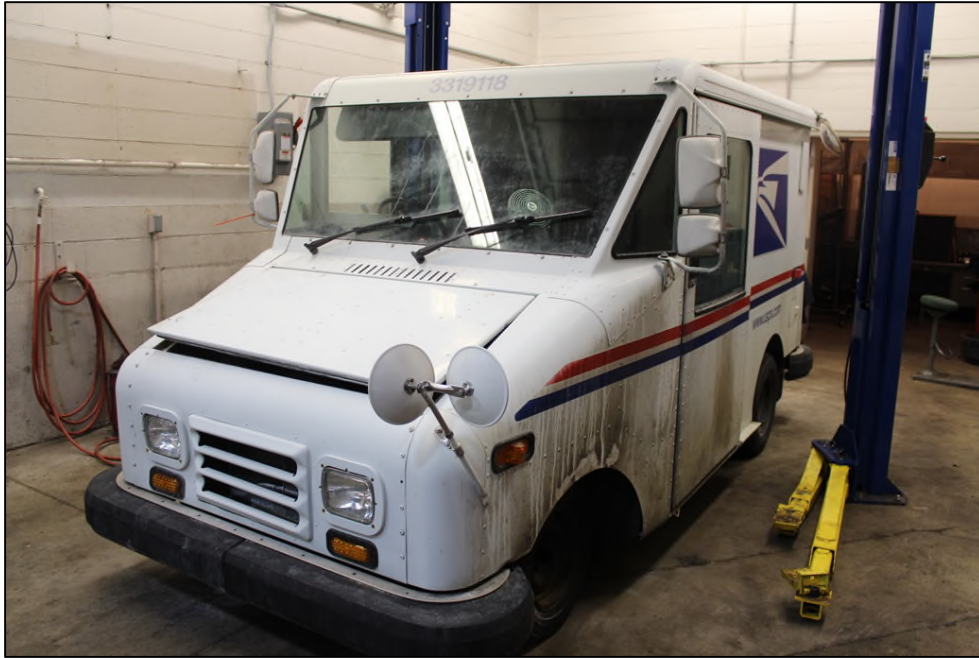
Photograph 1

Left side of vehicle with smoke stain on fender and door.

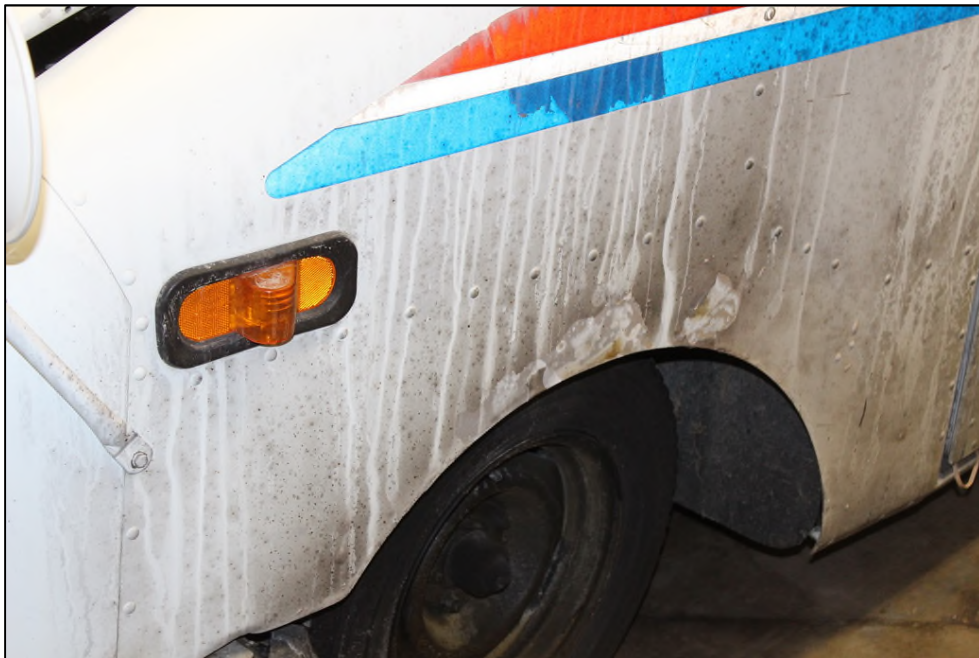
Photograph 2

Left front fender well with smoke stain and blistered paint.

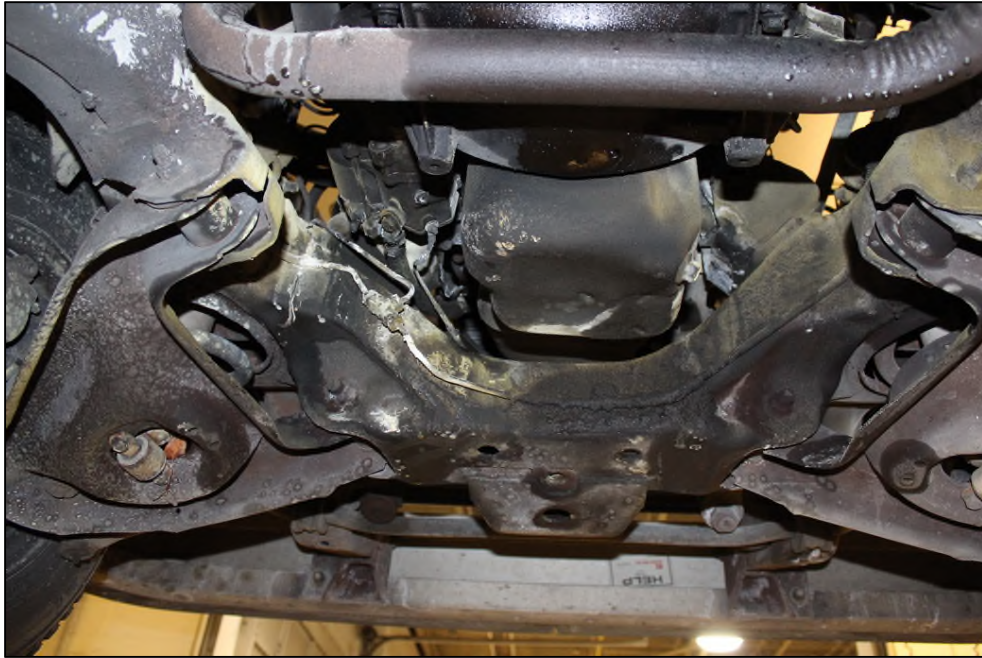
Photograph 3

Underside of engine with smoke stain and fire damage to left side.

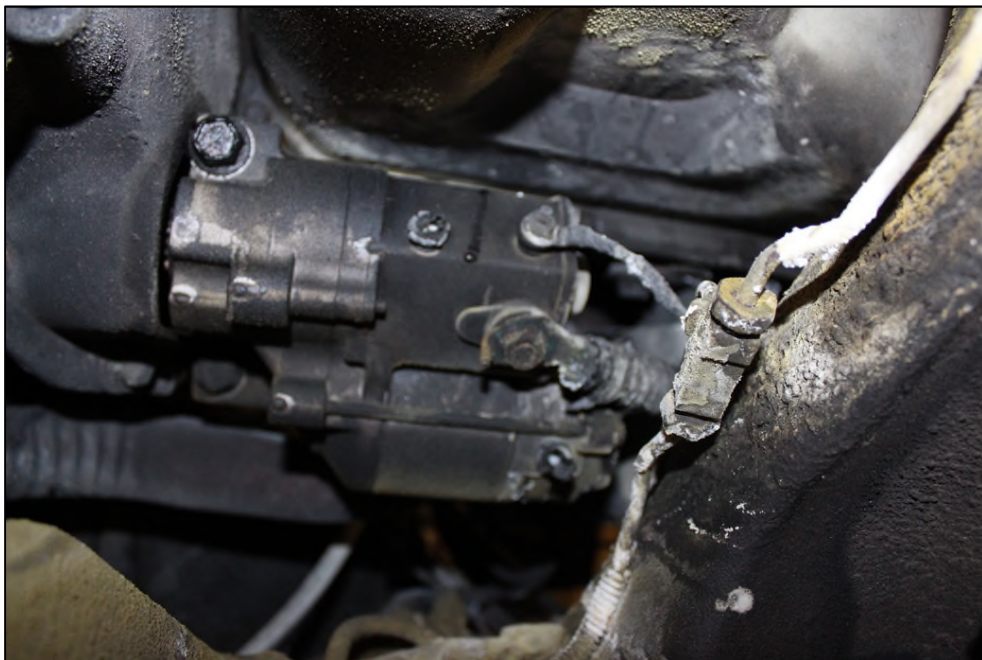
Photograph 4

Left underside of the engine, area of fire origin at the starter.

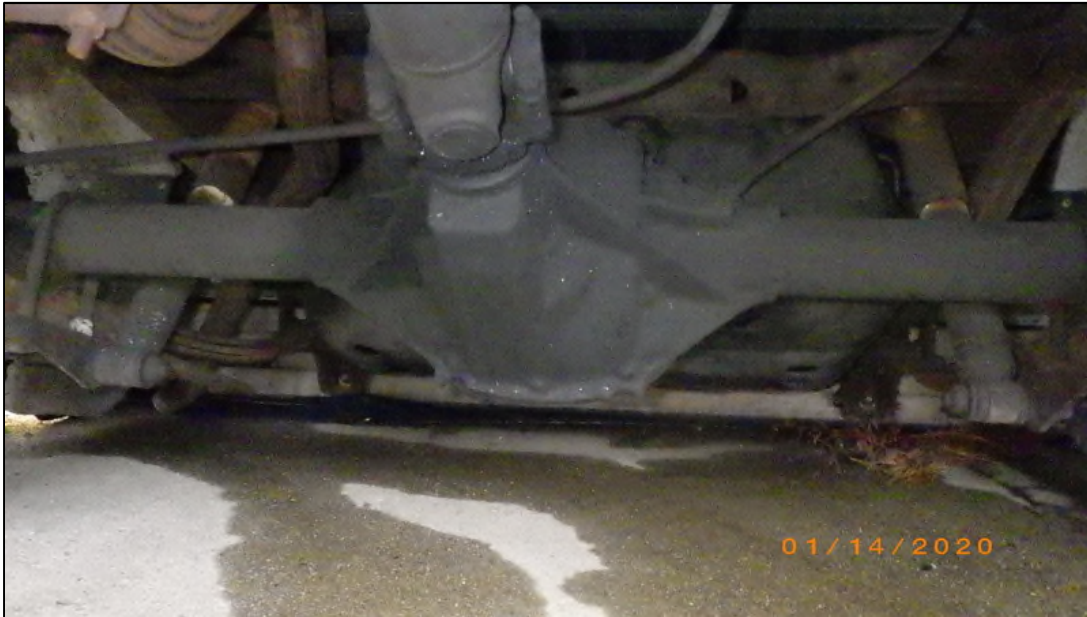
Photograph 9

A view of the rear undercarriage.

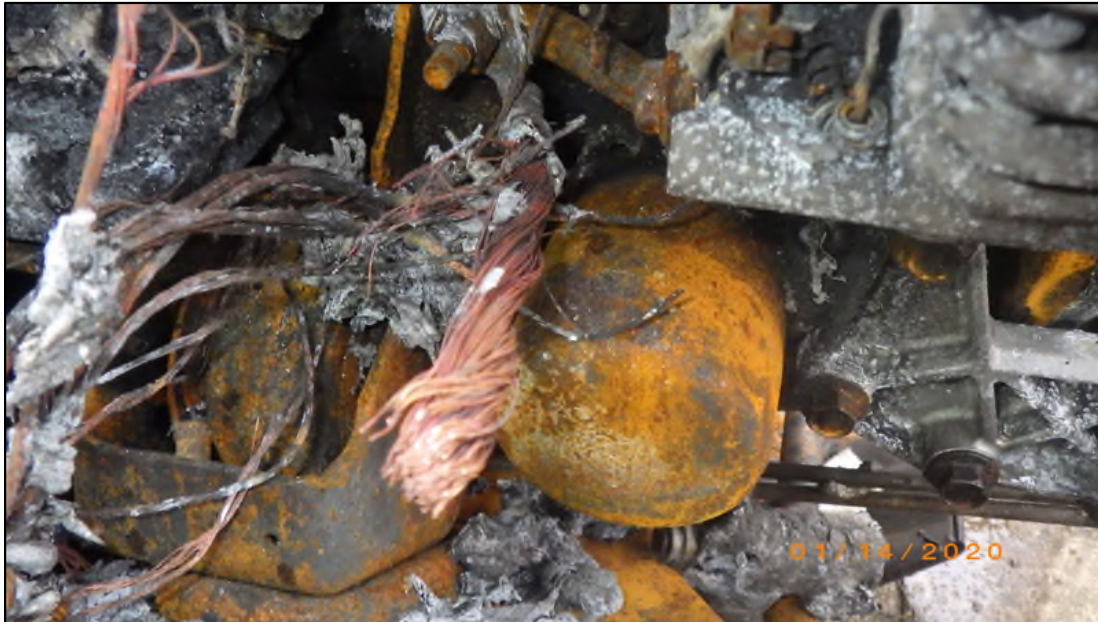
Photograph 13

A view of the severed main ground conductor.

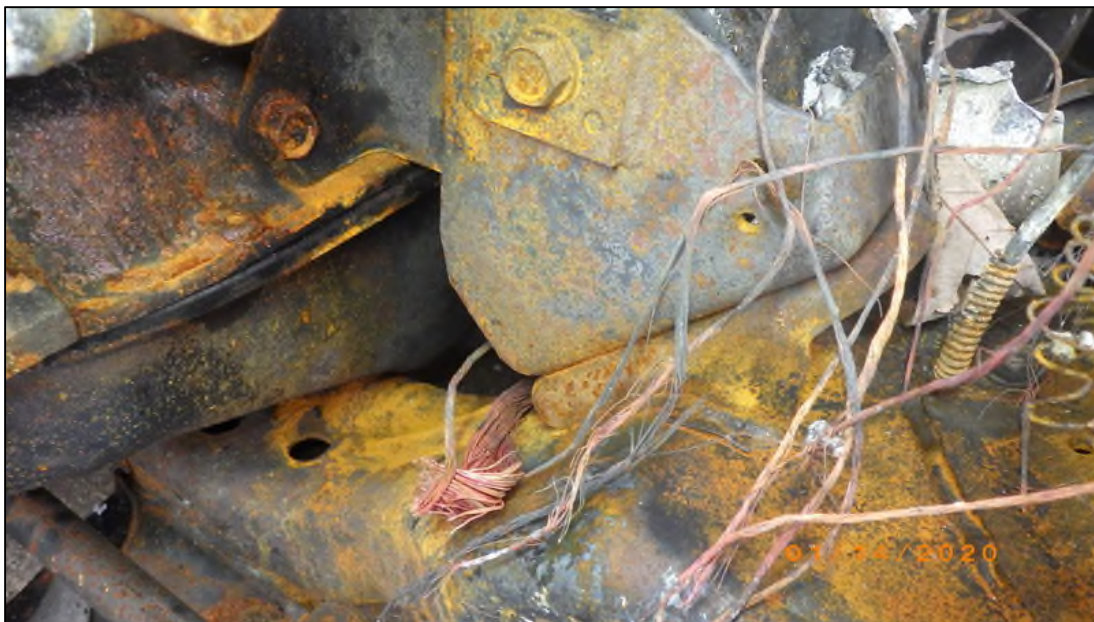
Photograph 14

A view of the severed conductor at the starter.

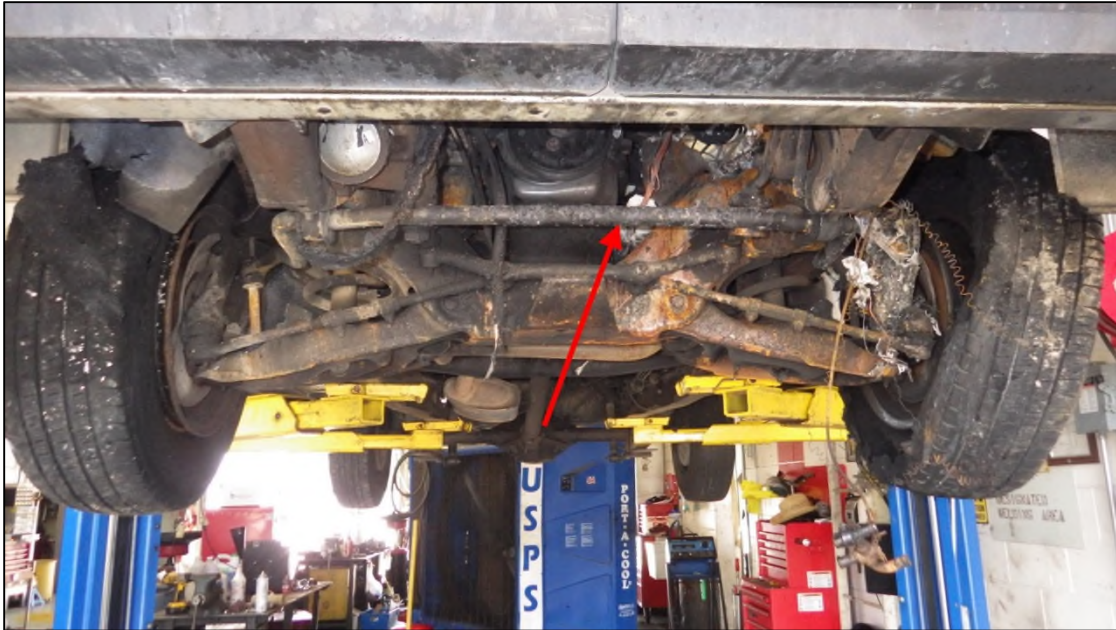
Photograph 3

A view of the battery cable.

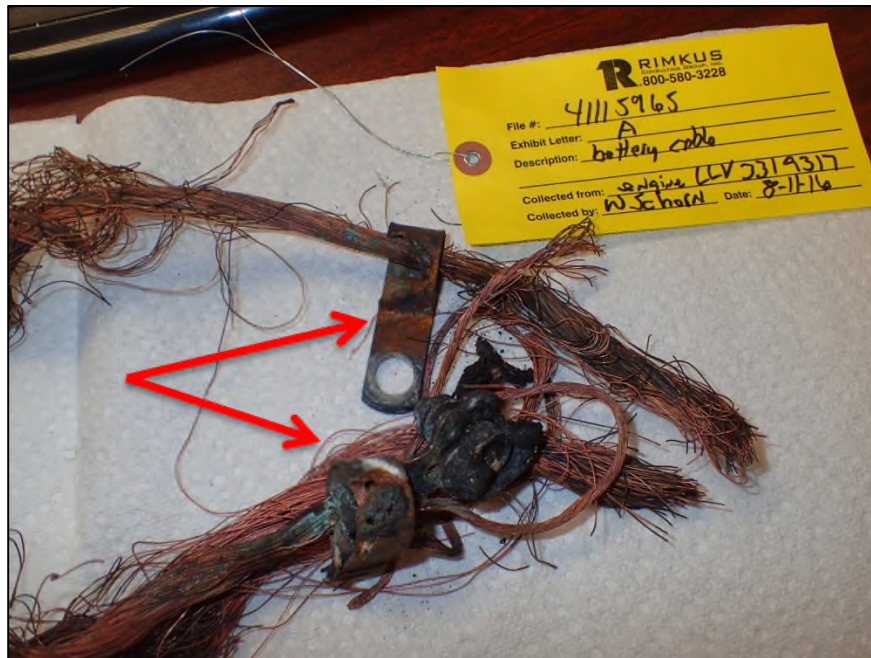
Photograph 5

A view of the evidence collected showing arcing in two brackets holding the battery cable.

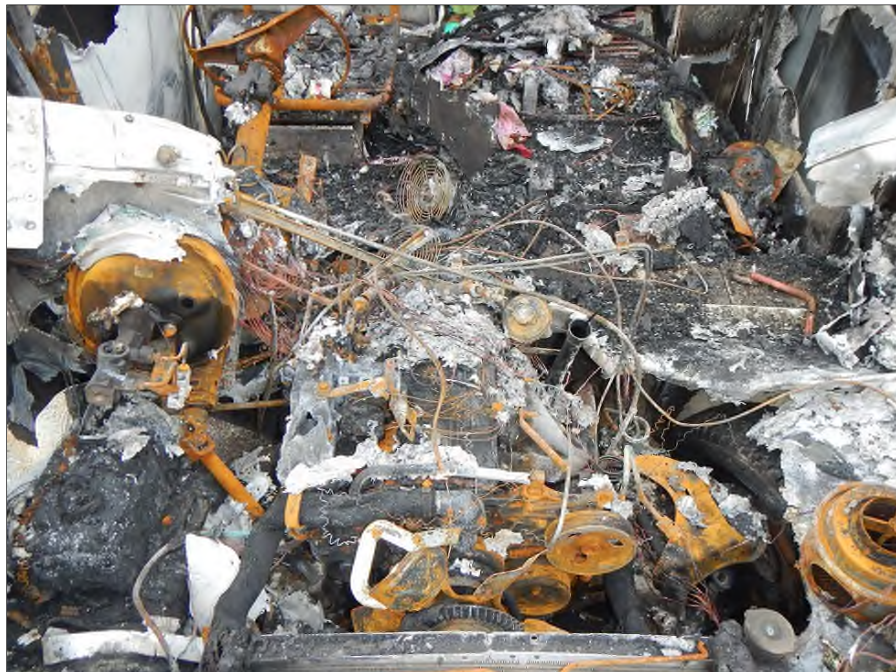
Photograph 4

During the examination of the engine compartment, we observed severe fire damage throughout the engine compartment. The most severe direct fire damage was observed on the mail side of the engine compartment. Fire patterns present on the radiator were consistent with the fire having extended from the left to the right side of the engine compartment. The engine compartment was determined to be the area of fire origin. Fire pattern analysis indicated that the fire originated in the area of the transmission and the exhaust system. An examination of the electrical conductors in the area of origin did not show any physical evidence of adverse electrical activity. The LLV was equipped with a GM fuel filter system. The LLV was also equipped with an AGI ignition distributor.

Overview of the engine and passenger compartments.

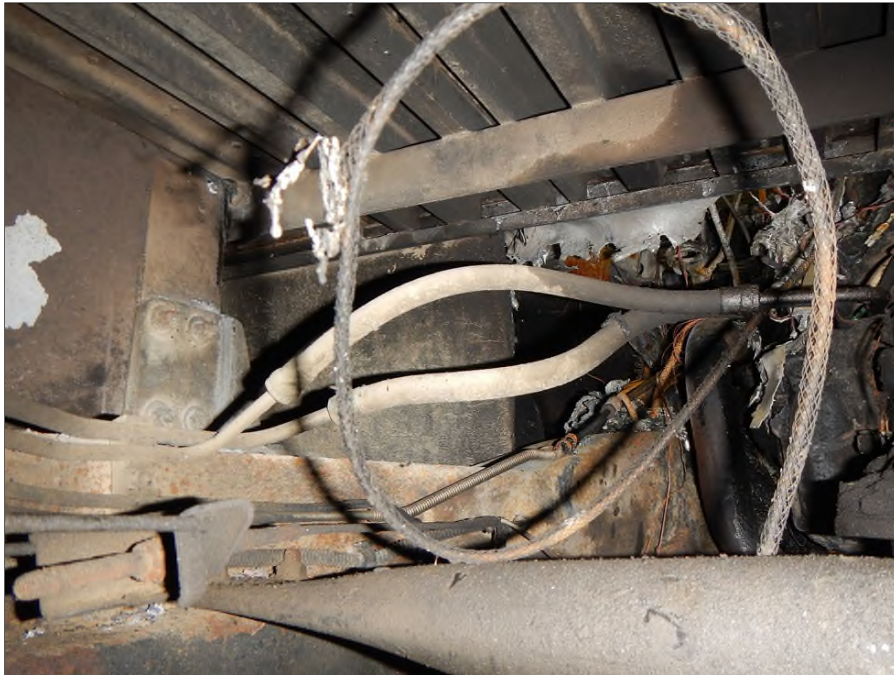
Photograph 5

We observed localized fire damage beneath the engine compartment of the vehicle. The fuel lines, which extended along the left side of the vehicle, were still intact and undamaged by fire. The oil pan drain plug and oil filter were both present and did not exhibit evidence of having leaked. We observed the presence of dirt/debris adhered to

Overview of the undamaged fuel lines.

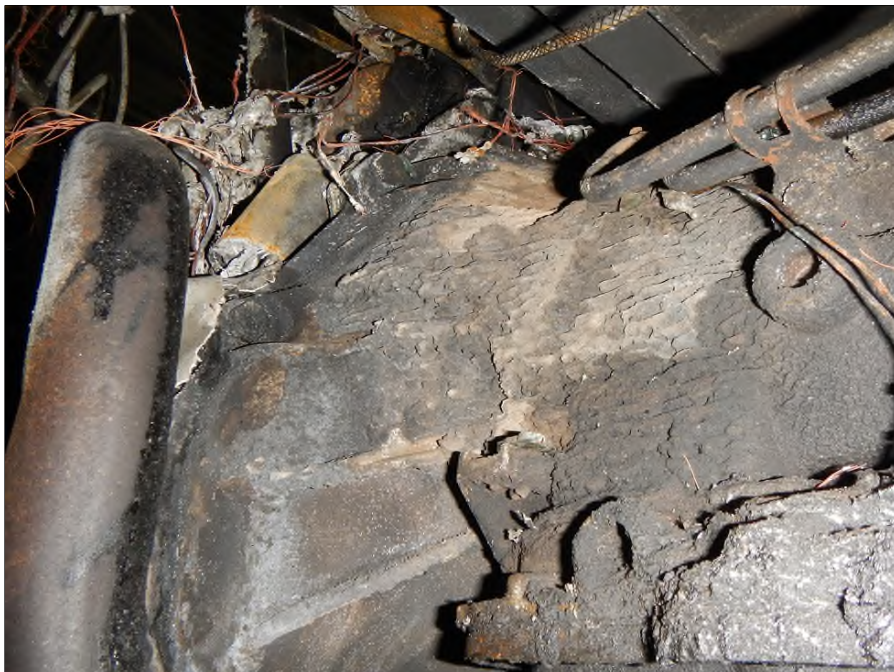
Photograph 6

the exterior of the transmission. The presence of this dirt/debris was consistent with a fluid leak having been present within this area. This fluid leak permitted the dirt/debris to adhere to the transmission. We observed the presence of transmission fluid on multiple components of the undercarriage. The presence of transmission fluid extended along the undercarriage to the rear of the vehicle. Transmission fluid was determined to have leaked on the hot operating components of the exhaust system which was the area of fire origin.

Overview of the dirt/debris adhered to the transmission.

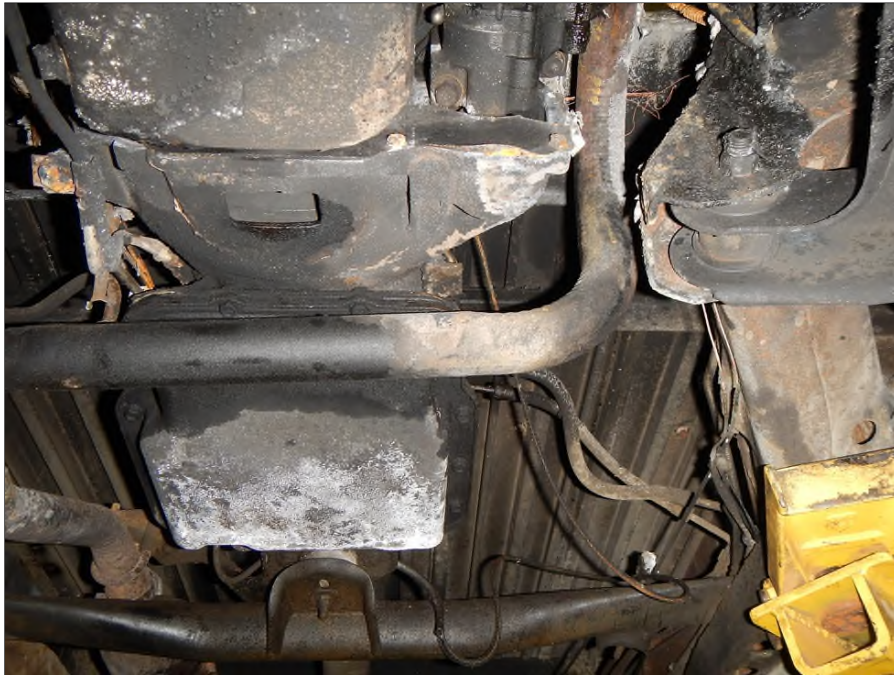
Photograph 7

We observed fire patterns that were consistent with the fire having originated beneath the engine compartment of the vehicle. The specific area of fire origin was located on the left side of the transmission at the location of the head pipe.

The evidence observed is consistent with a transmission fluid leak. The most probable cause for the fire was the ignition of leaking transmission fluid vapor by a competent ignition source. The competent ignition sources in the area of origin would have been the hot surfaces of an engine component. Due to the extent of fire damage, the specific location of the transmission fluid leak could not be determined.

Overview of the area of fire origin.
